Structural Analysis of DEW Line Station DYE-2, Greenland 1983-1988

Michael R. Walsh and Herbert T. Ueda

June 1998

CRREL Report 98-3

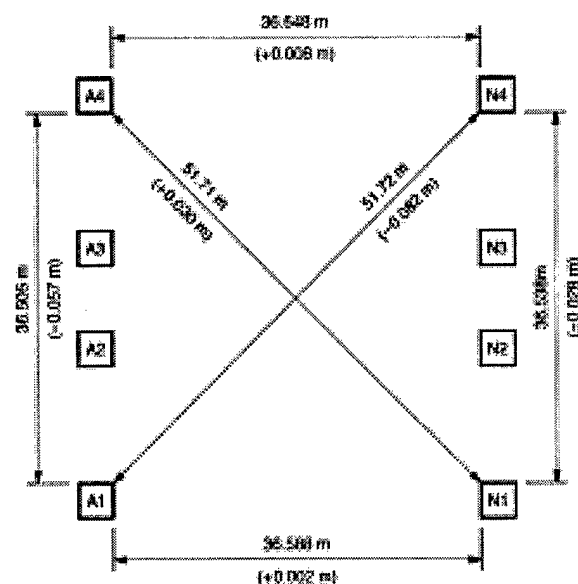
Figure 10. Horizontal movement of columns at snow surface.

Finally, as the footings settle and the ice cap drifts (App. A), the columns move differentially with respect to each other (Fig. 10). This differential movement, in addition to the column out-of-plumbness mentioned above, sets up horizontal distortions in the column-truss system that can result in high loads at restraining points at the collars and in the building. High bending moments at the column bases are a result of these large horizontal loads. The horizontal distortion of the truss system may also be the reason why pinching and spreading loads sometimes appeared during sway bolt measurements (described in

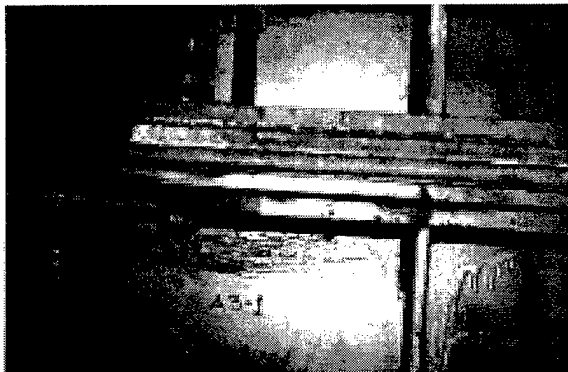
Figure 11. Leuder lines: column A base.

the next section). Leuder lines, distortions in the surface of a structural member indicative of localized yielding, were first observed in the supporting structure at the base of the columns below the footing support blocks in early 1988. These Leuder lines were thought to be evidence that high horizontal stresses, and therefore high moments, were being experienced by the columns. An example of Leuder lines is shown in Figure 11, which shows evidence of yielding below the support block of column A3.

- Footing tilts continued to increase as expected.
- There had been no significant increase in stress-induced Leuder lines in the bearing block supports on all column footings since June of 1988 (2 months). This was a qualitative assessment and indicated no further yielding in the supporting structure at the column bases over the summer. Later examination of photographic data showed

no increase in Leuder lines since the mini-life-extension operation in mid-1987, leading to the conclusion that the yielding had occurred during that work and not afterwards as previously thought.

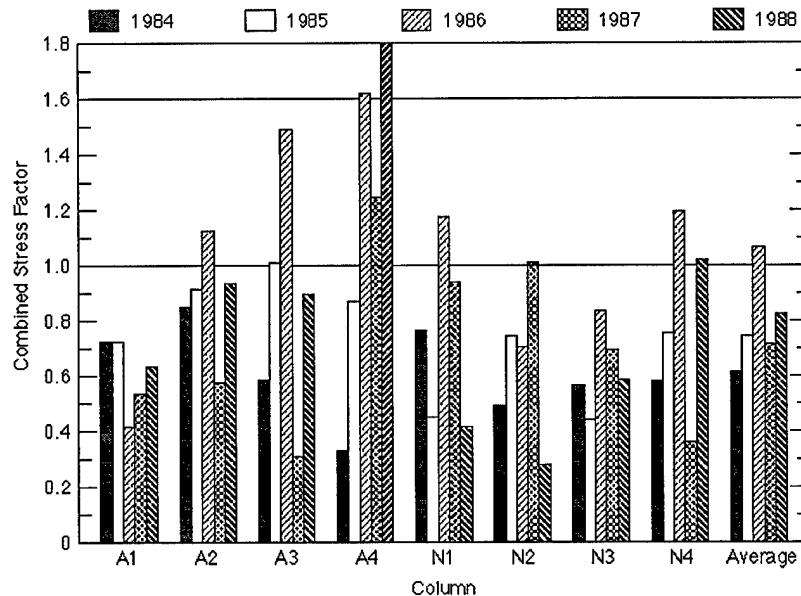
Figure 12. Summary of base level stress concentration factors: 1984-1988.

In 1984, after the building was moved and raised, stress levels were relatively uniform and

low, with an average base level combined stress factor (BLCSF) of about 0.61. BLCSFs are calculated loads on the column bases caused by stresses measured in the four collars of each column. There is no obvious pattern to the stress levels. None of the column BLCSFs exceed 1.00. In 1985, the stresses have become redistributed. The average BLCSF has increased to 0.71, with one column exceeding 1.00. Again, no pattern is obvious, although the A row is more heavily loaded than the N row.

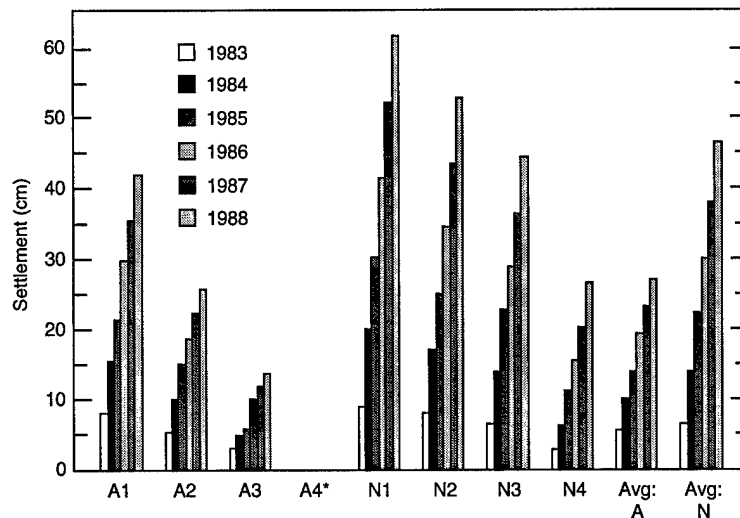
Figure 13. Footing settlements: 1982-1988.

at differing rates. Figure 13 shows the settlements of the A and N row of columns, as well as the averages of each respective row. Footing A4 was used as the datum point as this was the slowest settling footing and was used as the "baseline" footing previous to the move in 1982. Therefore no settlements are given for it.

From these figures, several observations can be made. The most obvious is that the N row is settling faster than the A row. The average rate of settlement of the N row with respect to A4 is 0.08 m/year. The settlement of columns A1 through A3 with respect to A4 is only 0.05 m/year. Footing settlement data can be found in Walsh (1992).

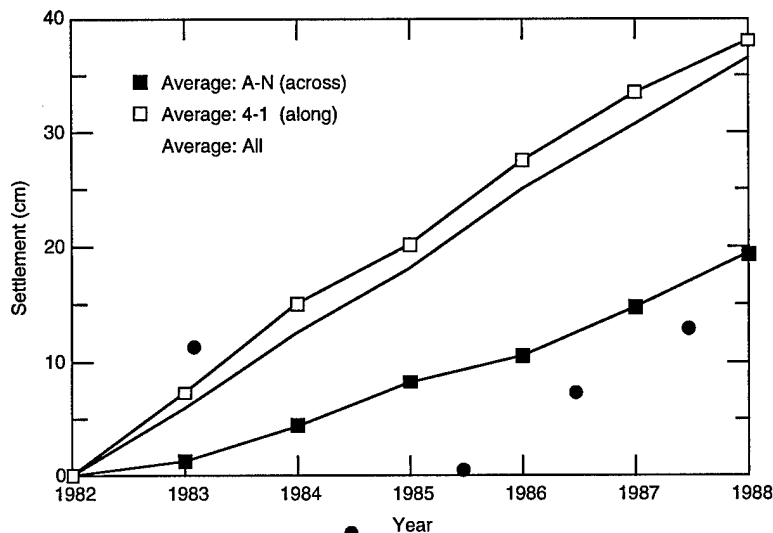
Figure 14. Footing settlement trends.

The across-row settlement as well as the along-row settlements for both rows show similar trends. Figure 14 shows these settlements for the years 1982 to 1988. Along-row settlements were normalized to A4 and N4 for their respective

A3, N3, and N4, we can see how this happens. As A3, N3 and N4 settle relative to A4, the building and truss also settle with respect to A4 at those locations. From Figure 14, the direction and magnitude of the footing tilts averages approximately 300° and 0.014 radians, respectively. The highest loads in the building and truss levels should then be at A4 with intermediate loads at A3 and N4 and the lowest loads at N3. The horizontal loads should be greatest where the settlement is least. Data taken during the 1988 field work confirm both conditions. This also applies to the forward truss.

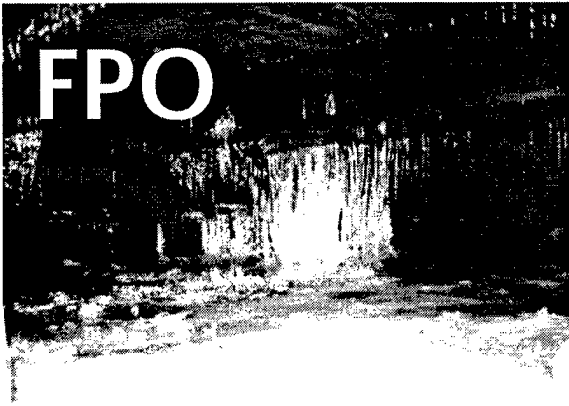
Figure 15. Flooding of footing N1, August 1988.

rows while across-row settlements were normalized to the A row. One important note to make here is that in August of 1988 approximately 2 m (6 ft) of water and ice was present in footing N1 (Fig. 15). This was an accumulation of over a meter (4 ft) since June of that year. The effect of the presence of this much water in the column footing may have led to weakening of the underlying packed snow foundation or even voids, depending on the amount of heat given off during the transformation of the water to ice and the contribution of the structural members within the footings to the dissipation of this heat. As the mean annual temperature at DYE-2 is around -16.6°C , there is a good chance some melting of the foundation may have occurred. However, with no borings conducted to verify this hypothesis, we can only postulate that the foundation was adversely affected by the presence of this water.

base level column load can be found in the opposite corner, at column A4. The presence of a large quantity of water at the base of column N1, covering the footing to a depth of several meters, indicates melting of surface and structural snow and subsequent runoff and collection in the column enclosures. These factors may indicate the cause of the tilt problem at DYE-2: changing snow conditions at the base of the "warm" side footings due to the presence of meltwater. Warmer conditions and the presence of water at the bases of these columns would cause melting or increased densification of the snow beneath these footings, which in turn would undermine the support these columns contribute to the structure. This would contribute to or even cause the differential settlement rates, column and footing tilts, and stress distribution patterns found at DYE-2.

- Footing settlements continued to be a problem. Settlement was linear over the span of time under consideration and showed no indication of slowing. N1 was of special concern due to the amount of water and ice present in the footing room ($\approx 2 \text{ m}$).

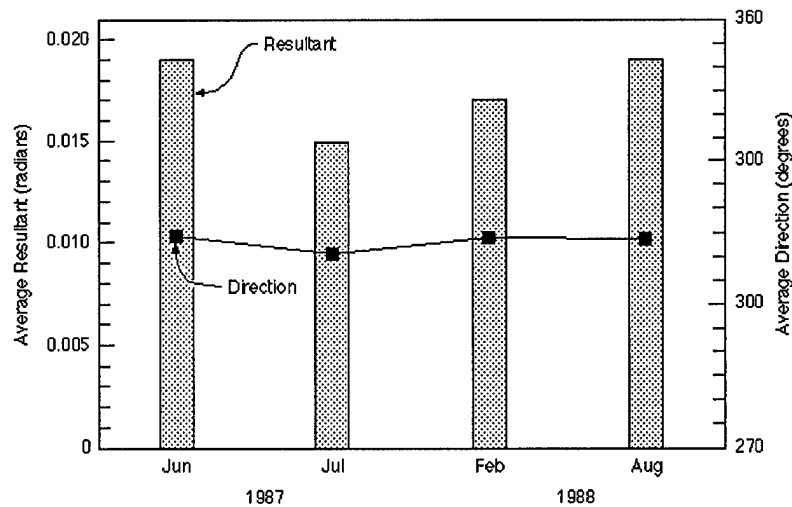
Figure 18. Column tilt trends.

causing the structure to become skewed. Although tilt measurements had only been taken on a regular basis since 1986, the data showed a disturbing trend: the columns were leaning at a rate that increased the out-of-plumbness by about 7 cm per year over a 29-m length. The column tilts affected the stresses experienced by the supporting structure in two ways. Axial loads no longer acted along the central axis of the columns, thereby generating moment loads at the base of the column where it attaches to the footing structure. Thus the angle between column and footing tilted. In addition, horizontal stresses are introduced at the truss connections (sway bolt locations) because of twisting forces on trusses. These were the static structural forces that were measured to determine the column stresses.

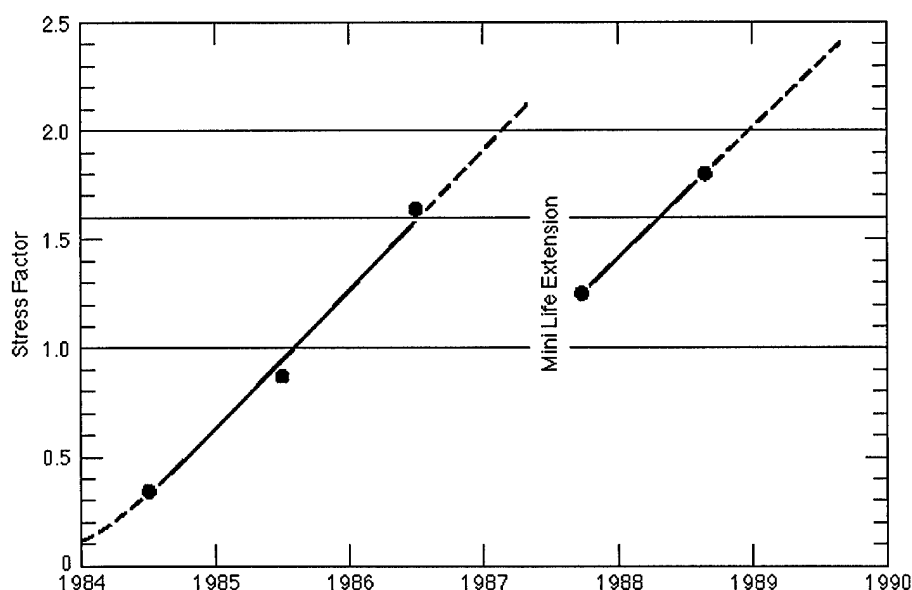
Figure 20. Extrapolation of base level combined stress factors for column A4.

not done. From the data, one can see a rise in the general state of stress in the structure, especially in column A4, which has a combined stress factor well in excess of 1.60. Extrapolation of this and previous years' data indicated a combined stress factor of more than 2.00 by year's end (Fig. 20).

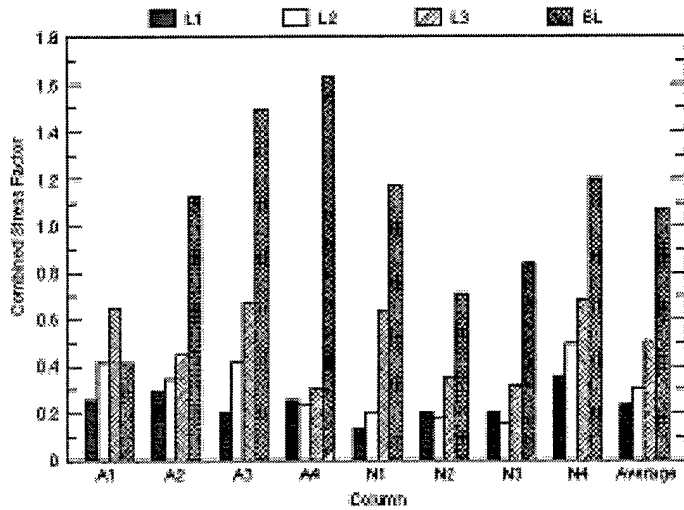
Figure B4. Swaybolt loads: 1986.

Figure B4 contains the third complete set of combined stress factors since the move in 1982. It is interesting to compare stress factors for 1984 through 1986 for trends. High stress concentration factors in general, and especially at column A4 (>1.60), led to a recommendation that work be contracted for the next summer to alleviate some of the high stresses. Column tilts were also a factor in this decision.

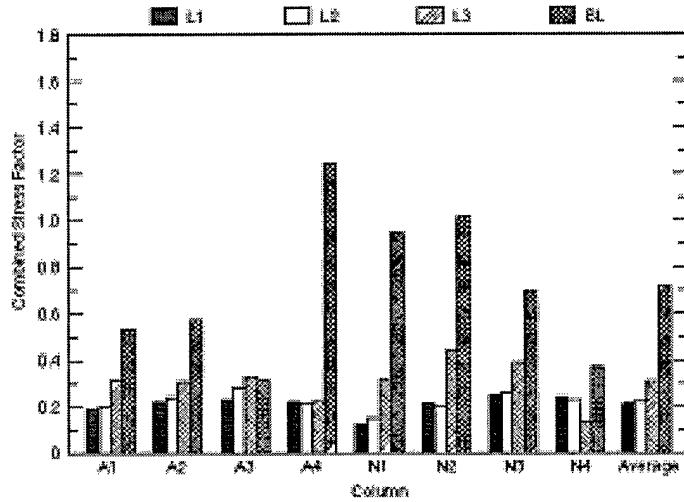
Figure B5. Swaybolt loads: 1987.

Figure B5 contains the fourth complete set of combined stress factors since the move in 1982 and the first since the mini-life-extension of 1987. Comparing stress factors for 1984 through 1987 points up several trends that are more obvious when examining Figure 12. Although the mini-life-extension served to lower most stress and redistribute stresses among the columns in general, trends dictated a repeat of the work performed in 1987 to assure the structural integrity of the building. Another mini-life-extension was therefore recommended for 1988.

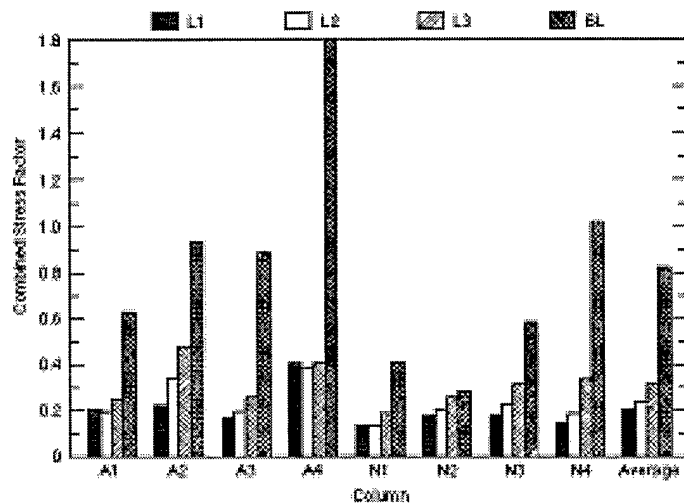
Figure B6. Swaybolt loads: 1988.

Figure B6 contains the final complete set of combined stress factors calculated for DYE-2 and the second since the mini-life-extension of 1987. Comparing stress factors for 1984 through 1988 points up several trends which are more obvious when examining Figure 12. Although the mini-life-extension was recommended for the summer of 1988, funding difficulties were encountered and the work was
